FPE Panels – Hazard or Hype?

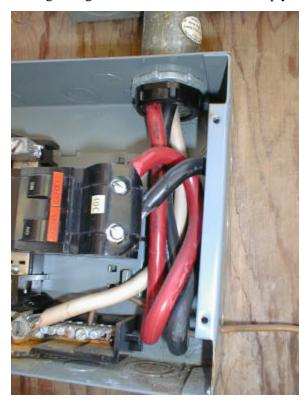
Figure 1 – Insufficient wire bending space

significant changes in the 1981 NEC, near the very end of the days when FPE panels were made. However, FPE was able to manufacture panels with even less clearance than the pre-1981 rules by installing the lugs at an angle, so the conductor was already parallel to the wall opposite the breaker terminal. However, the bends shown in figure 1 defeat the purpose of the angled lugs, and the wire is bent too sharply.

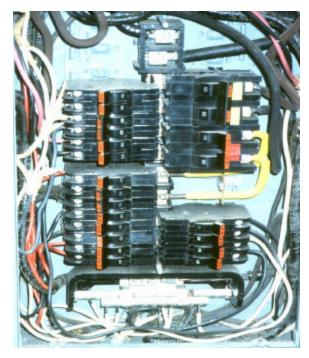
Figure 3 - Split Bus Panel

Prior to 1984, many manufacturers offered "split bus" panels for residential use, such as the panel in figure 3. These panels have no main breaker. Instead, they met the rule requiring no more than 6 disconnects, and one of these disconnects feeds a separate bus that typically contains the 15 and 20 amp 120 volt circuits. The advantages of a split bus panel were purely economic. If the largest breaker was the one feeding the secondary bus, and it was rated at 50 amps, it cost less than a single main 100 amp breaker. In addition to the well-known "six disconnects" rule for service equipment, another rule also applies to panels that are categorized as "lighting and appliance" panels. These are panels where more than 10% of the breakers are rated 30 amps or less and serve circuits with neutrals. These lighting and appliance panels must be capable of having their power disconnected by not more than 2 hand movements. Until 1984, the code exempted these panels from the "twodisconnects" rule when they served as residential service equipment. Today, the code allows them to remain when they are "existing" service equipment, though it would not allow a new installation of such a panel.

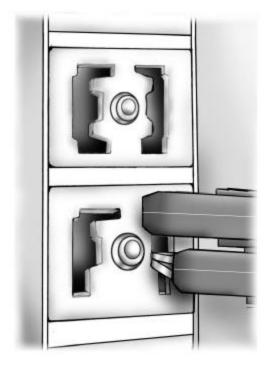
Figure 4 – "E" & "F" bus slots

Most plug-in circuit breakers have a set of jaws that fit over a bus bar, bringing the metal of the jaw into a parallel position to the bus bar. The FPE Stablok design is the opposite; the breakers have a set of prongs that are inserted into a slot in the bus bars (figures 4&5). The result is a connection between two pieces of metal that are at right angles to each other, only touching at their edges. One of the common FPE problems is to find the breakers loose in the bus bars. Good electrical connections require contact pressure. If the FPE stab only touches one edge of the opening in the bus, the lack of contact pressure and the small contact area will combine to produce arcing and overheating. A common report from the field is to find scorch marks on FPE bus bars once the breakers have been removed, as in figure 6.

The problem with this arrangement is that the "E" breaker stabs can be bent over and jammed into an "F" socket, and the result is another poor connection, as well as an overcrowded panel. Figure 4 illustrates this condition.

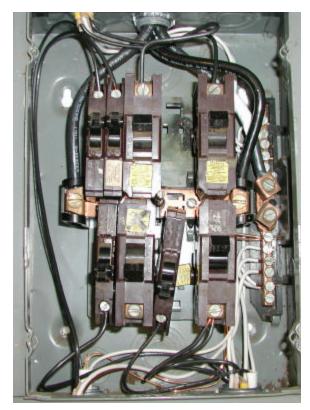
Figure 8 - Loose breaker

Not only will the "E" breaker make a poor connection in the "F" socket, it can be damaged as a result of being forced into the socket. If the installer pushes hard enough on the breaker, it will split and the bus stab will recede inside the molded case of the breaker, as in figure 7. Since it is now making a very loose contact to the bus, the breaker might fall right out when the deadfront cover is removed. Figure 8 shows an example of that condition. Inspectors can be forewarned of this condition before taking off the cover. Simply look at the label for the panel to see where the "E" slots are located and whether any "E" breakers have been inserted into "F" slots. When finding that situation, there is no need to remove the cover to know that the breaker is in the wrong position.
